# WEST HUMBER RIVER HABITAT REHABILITATION PROJECT

## PROJECT GOAL

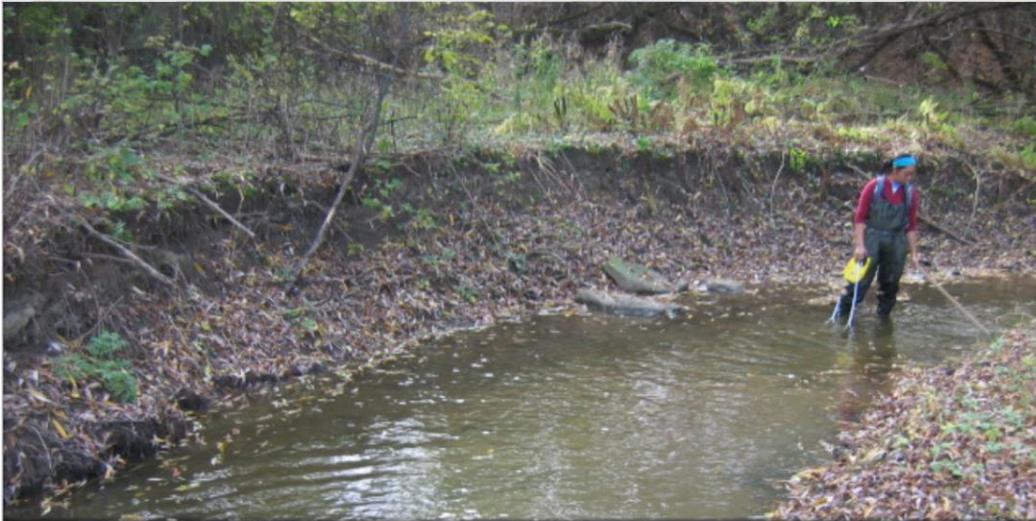
Stream bank erosion in Kilmanagh Creek (2012), resulting in stream widening and sediment being washed downstream.

- Aquatic habitat enhancement through the creation of habitat and stabilization of eroding stream banks including the installation of cabled debris jams, cabled log jams, and the installation of anchored logs and root wads. Ontario Streams installed over 36 structures that will provide the stream bank with protection from erosion and cover and habitat for fish. In many cases, these construction projects were completed using naturally occurring woody
